Manhole Inspection Summary

Manhole # S33YY1002MH

Location Address: **5303 SPRINGLAKE WAY**

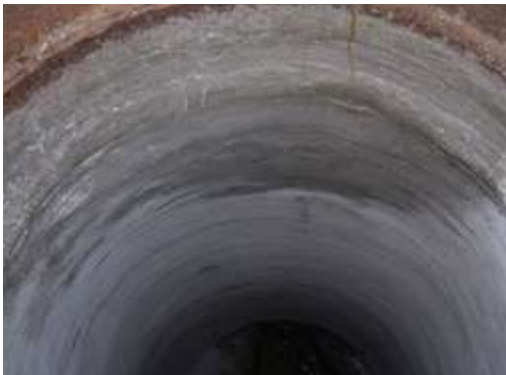
Defect

Frame Offset: **0** (in.) Condition: ☐ Sound ☐ Cracked ☒ **Leaks**

Infiltration: ☐ None ☒ **Joint** ☐ Cracks ☐ Mortar ☐ Roots ☒ **Wall**

Frame leaks. Adjustment infiltration.

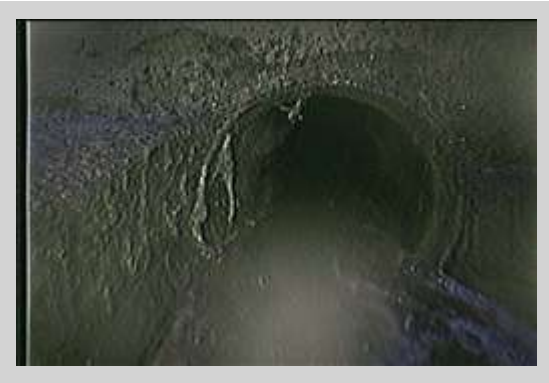
12 in. Circular Gravity Sewer Pipe Out @ 12 O'Clock

Infiltration: **Evidence** Pipe Seal Cond: **Unknown**

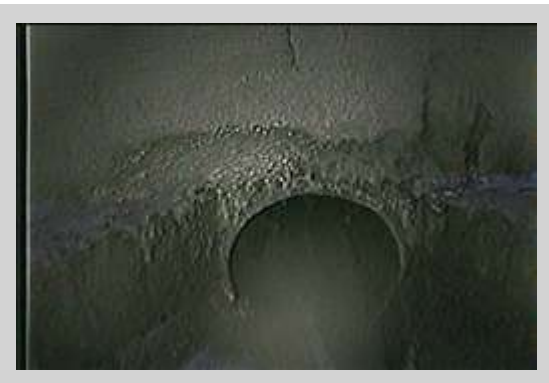
8 in. Circular Gravity Sewer Pipe In @ 3 O'Clock

Infiltration: **Evidence** Pipe Seal Cond: **Unknown**

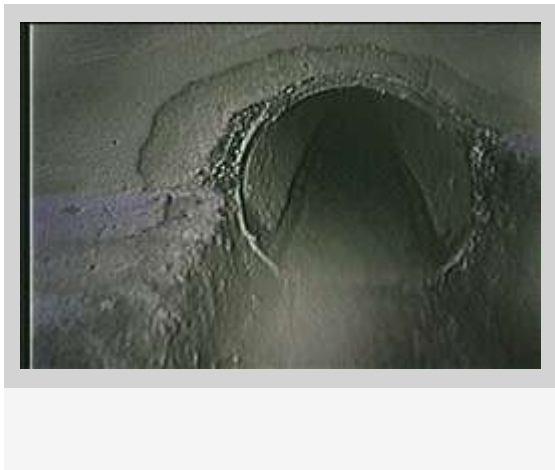
12 in. Circular Gravity Sewer
Pipe In @ 6 O'Clock

Infiltration: **Evidence** Pipe Seal Cond: **Unknown**
